Update "With-Site-Visit" Reserve Study

Tempe Gardens Tempe, AZ

**Report #: 25627-1
For Period Beginning: July 1, 2018
Expires: June 30, 2019**

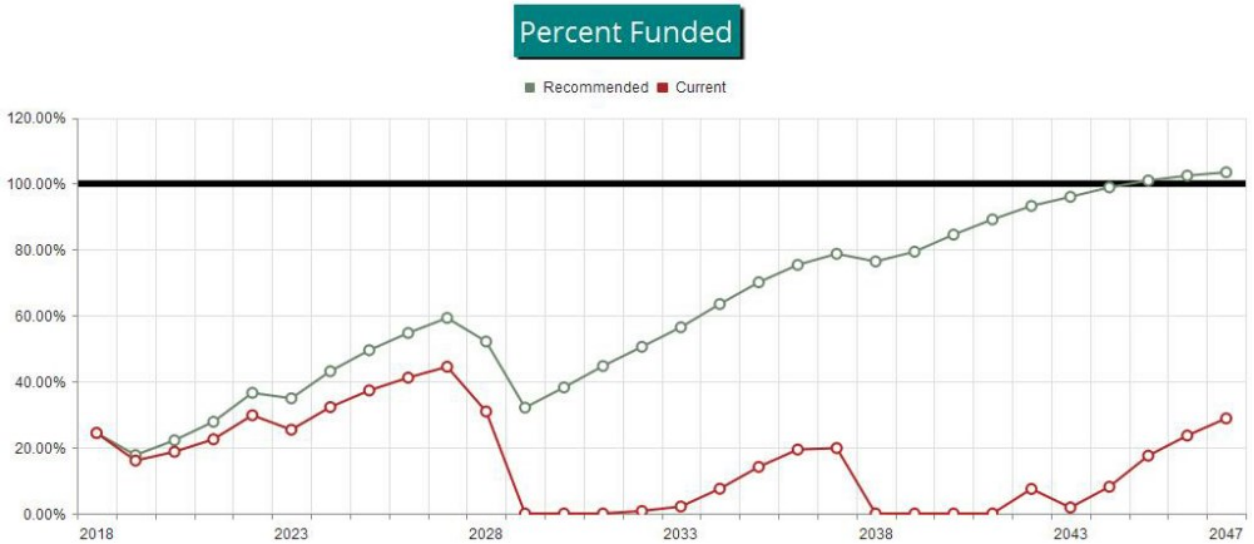
Figure 4

This chart shows the same information plotted on a Percent Funded scale. It is clear here to see how your Reserve Fund strength approaches the 100% Funded level under our recommended multi-year Funding Plan.

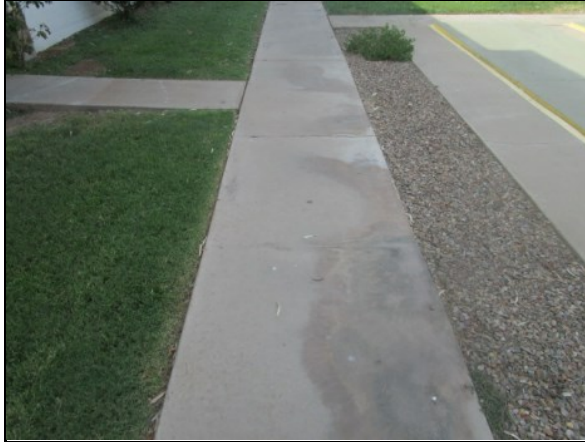
Useful Life:
5 years

Remaining Life:
1 years

Best Case: \$ 3,000

Worst Case: \$ 3,600

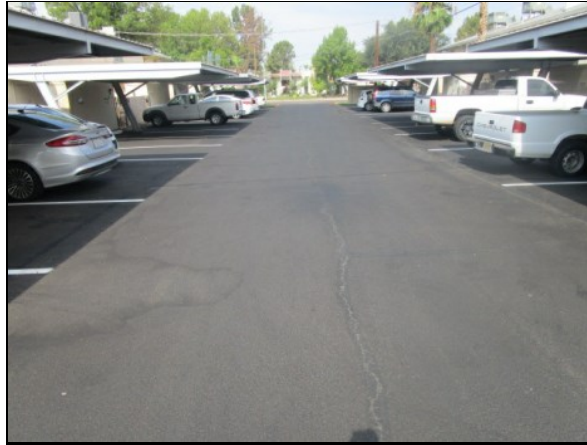
Useful Life:
24 years

Remaining Life:
19 years

Best Case: \$ 60,000

Worst Case: \$ 70,000

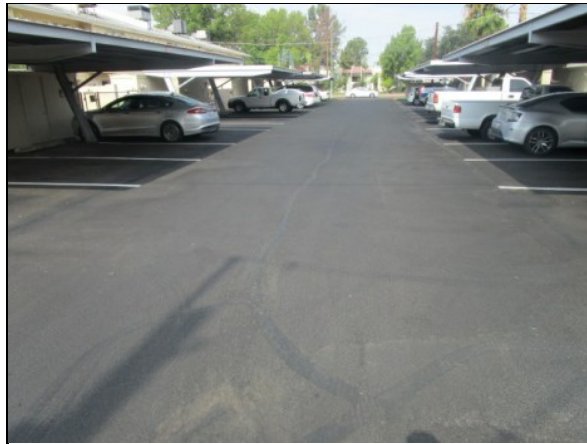
Useful Life:
4 years

Remaining Life:
0 years

Best Case: \$ 5,200

Worst Case: \$ 7,000

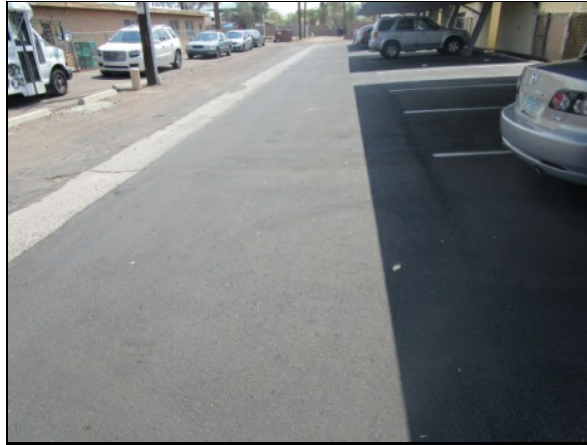
Useful Life:
24 years

Remaining Life:
20 years

Best Case: \$ 62,000

Worst Case: \$ 72,000

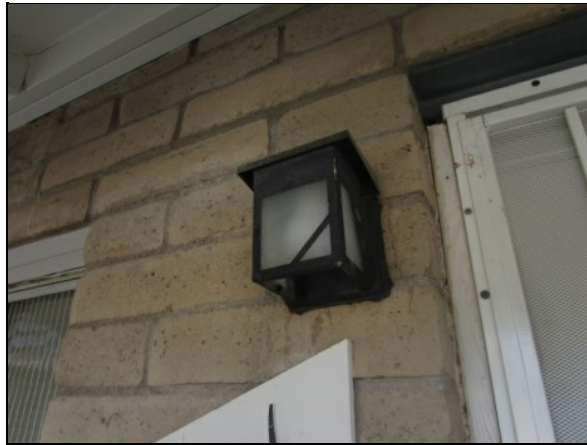
Useful Life:
20 years

Remaining Life:
0 years

Best Case: \$ 46,400

Worst Case: \$ 56,600

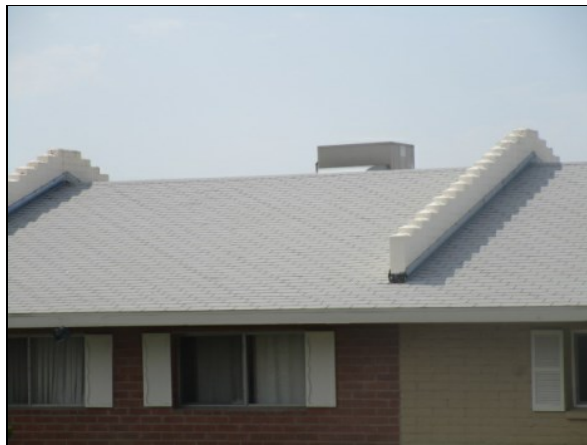
Useful Life:
20 years

Remaining Life:
10 years

Best Case: \$ 370,000

Worst Case: \$ 460,000

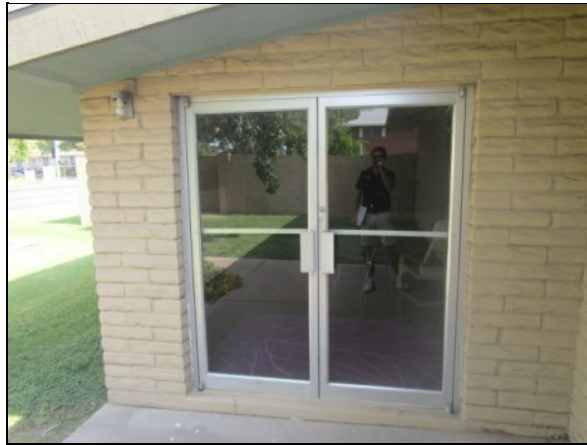
Comp #: 880 Doors & Windows - Replace

Comments: This component accounts for (3) exterior access doors, (1) set of 6'x7' storefront doors, and (1) set of storefront doors and windows leading to the pool area. Expected to be original for the most part. Replacement should be planned eventually, especially as part of renovating the building. Remaining useful life is based on age.

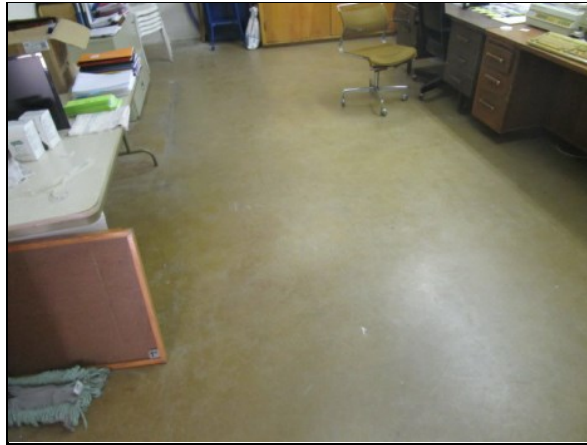
Comp #: 902 Concrete Floor - Replace

Funded?: No. There is no expectancy to replace the concrete and no plans to install a different type of floor cover over it, so no Reserve funding has been allocated.

Comments: Majority of the clubhouse interior has a colored concrete floor. Clubhouse receives little use, so floor surface is not worn.

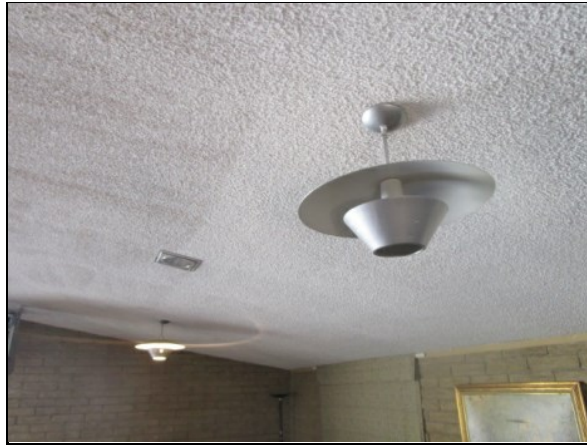
Comp #: 910 Interior Lights - Replace

Comments: Light fixtures include (6) hanging lights, (2) large wall lights, (6) fluorescent lights, (2) ceiling lights, (1) ceiling fan, and (5) exit lights. Ages and conditions vary. Recommend planning to replace all of the fixtures at some point to update the lighting and appearance.

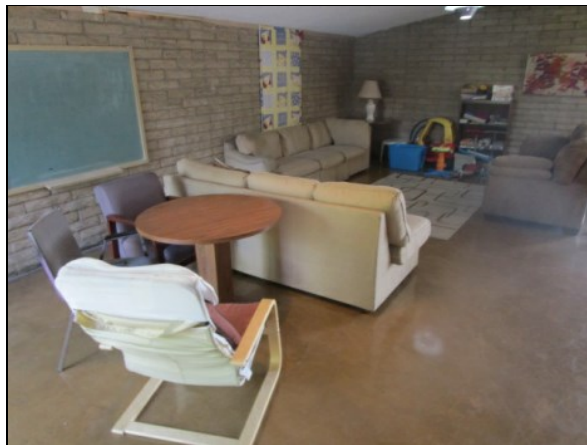
Comp #: 920 Furniture - Replace

Comments: Pieces include (1) dining table, (4) round tables, (3) sofas, (13) assorted chairs, (1) coffee table, and (1) end table. Furniture is old and dated. Recommend planning to replace in the near future as part of refurbishing the clubhouse.

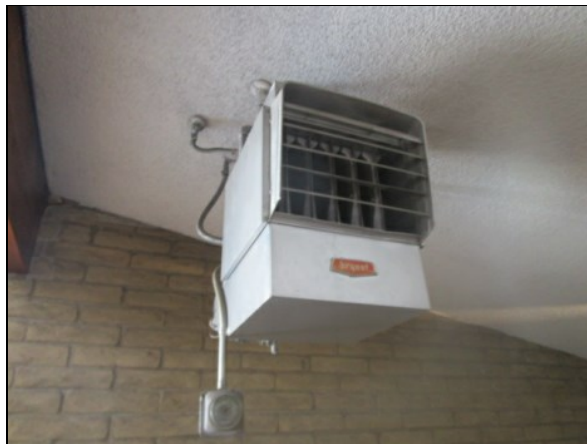
Comp #: 930 Space Heaters - Replace

Funded?: No. Exhaust vents are not even attached, so heaters are no longer in use. At this point, we assume HOA will not replace them. No Reserve funding has been allocated.

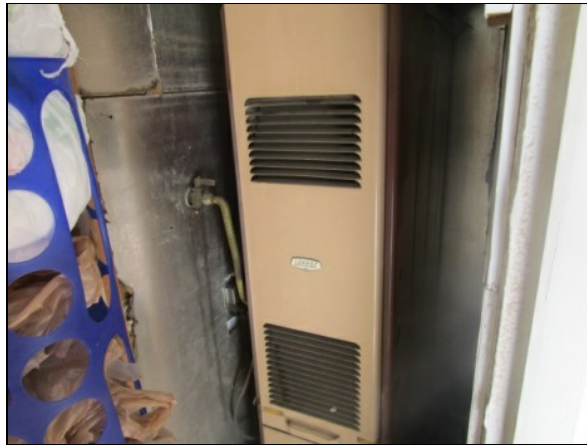
Comp #: 934 Furnace - Replace

Comments: Furnace is turned off and not being used. It looks old, possibly even original. It is only has ducting to service the south side of the building. Expect to replace this unit eventually.

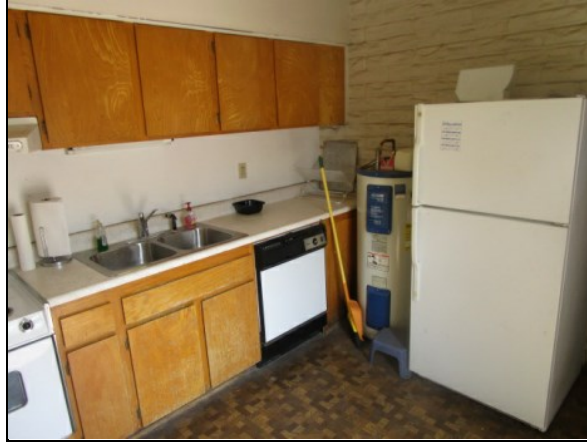
Comp #: 942 Kitchen Appliances - Replace

Comments: Appliances include a refrigerator, dishwasher, electric stove, and a hood above the stove. This is old equipment, but we assume they are still functional. Recommend upgrading appliances when kitchen is remodeled. Replace individually as a maintenance expense if needed.

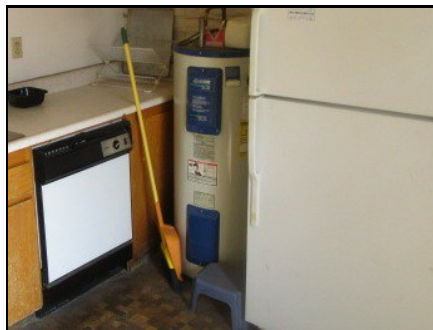
Comp #: 945 Water Heater - Replace

Funded?: No. Replacement of this water heater should be treated as a maintenance expense when needed.

Comments: Water heater was installed around 1992. It is old with a lot of rusting around the bottom of the tank. Model: 5-40-2KRS8-FJ, Serial #A92486773.

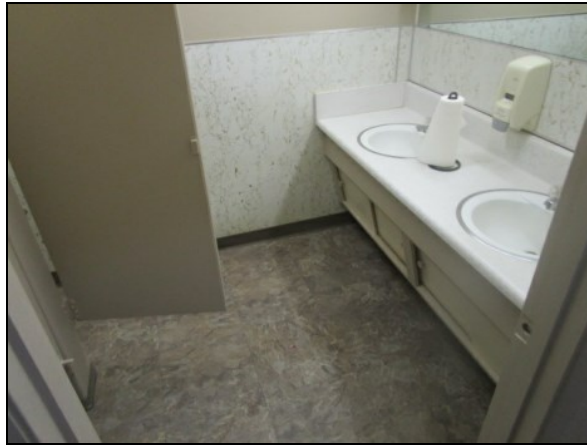
Comments: Restrooms are in generally good condition. Appears to have been updated within the last 5 years. The update was done mostly in-house for a minimal expense. A company was hired to do the tiles for \$1400. Planning for a more extensive remodel on roughly the schedule below.

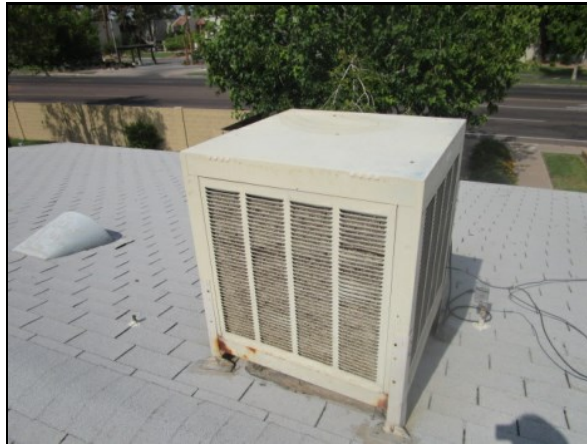
Comp #: 1330 Evaporative Coolers - Replace

Comments: These coolers are older. One has a fiberglass shell, and the other two are metal and were installed around 2001. Some rusting noted. Replacement should be expected eventually.

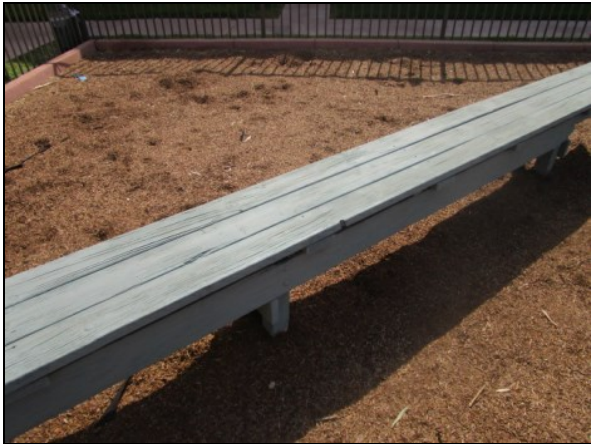
Comp #: 405 Park Benches - Replace

Comments: Wood benches are permanently mounted in-ground. Posts are getting worn. Bench looks older, but it is still functional. Replacement should be expected eventually.

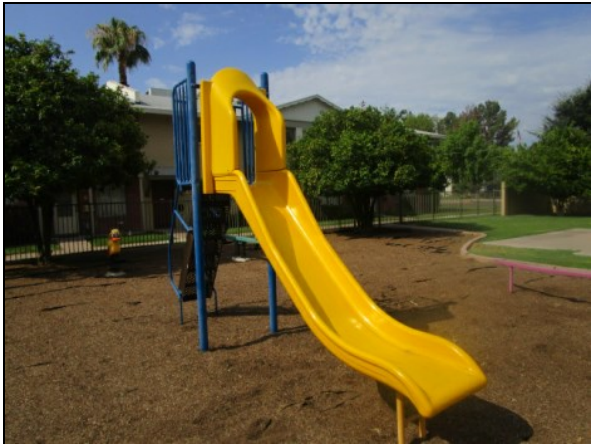
Comp #: 410 Playground Equipment - Replace

Comments: Equipment includes a climber, swing set, horizontal ladder, slide, spring rider, seesaw, and balance beam. Equipment appears to vary in age. All pieces look functional and intact. HOA should expect to completely replace the equipment at some point to renovate the playground.

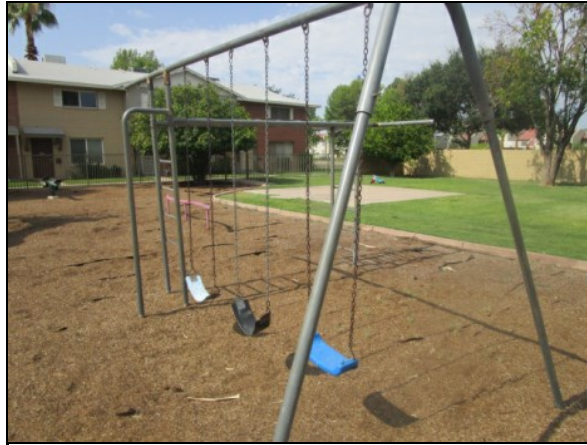
Comp #: 412 Playground Equipment - Repair

Comments: This component provides an allowance to periodically repair the playground equipment as needed.

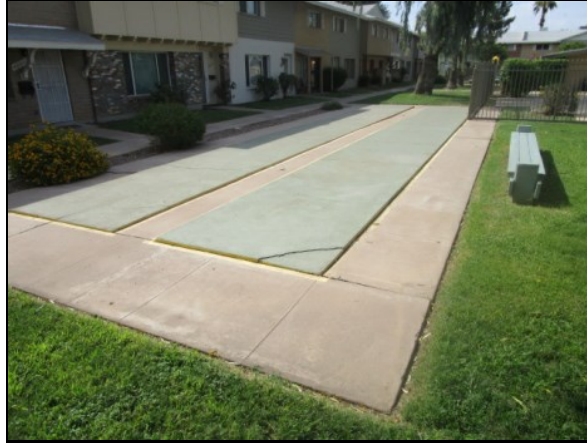
Comments: These are concrete shuffleboard courts. Coating is completely worn off. Surfaces are cracked and not useable for shuffleboard.

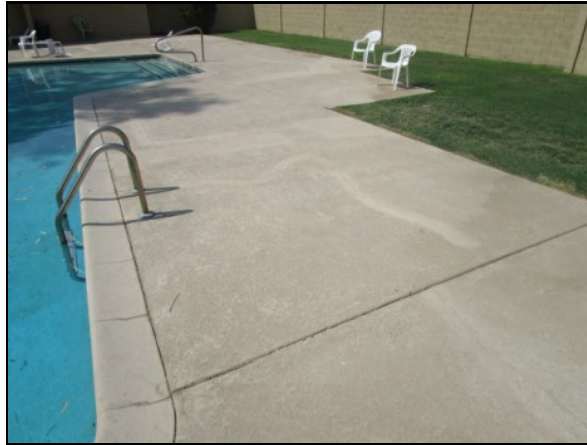
Comments: The pool deck has a combination of painted concrete and a kool deck coating. Surfaces are fair with some cracking. Plan to seal/coat in the near future, then plan for a larger resurfacing project.

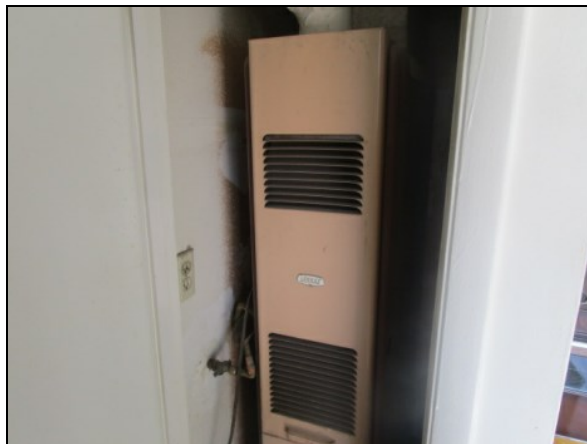
Comp #: 934 Furnace - Replace

Comments: Furnace is turned off and not being used. It looks old, possibly even original. It is only has ducting to service the south side of the building. Expect to replace this unit eventually. Model: GH7D-80M, 80,000 BTU input.

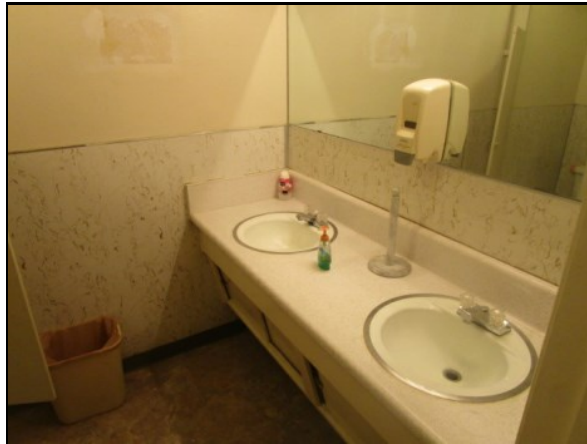
Comments: Restrooms are in generally good condition. New tile was installed in-house for a minimal expense. Planning for a more extensive remodel on roughly the schedule below.

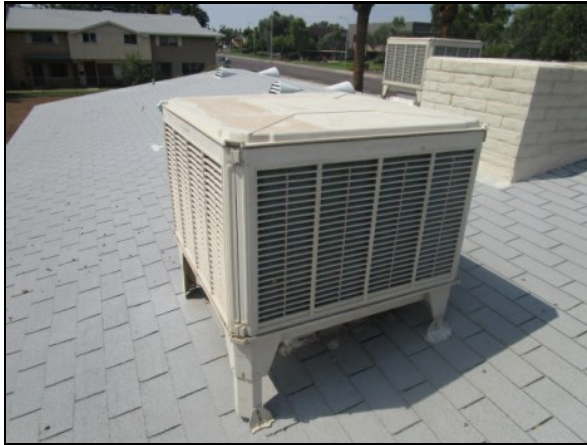
Comp #: 1330 Evaporative Coolers - Replace

Comments: These coolers have a fiberglass shell, so there are no issues with rusting. They appear to be older but in fair condition. Still functional at the time of inspection. Replacement should be expected eventually.

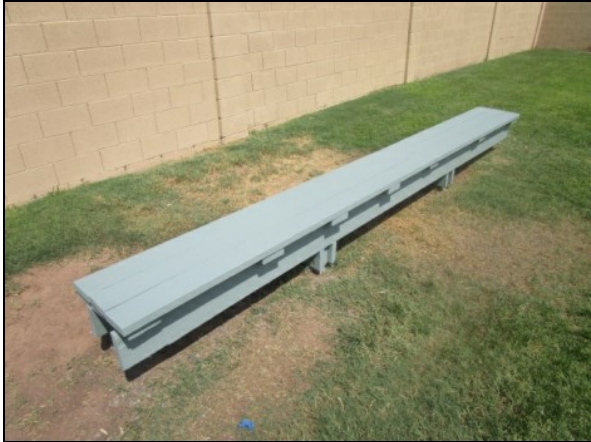
Comp #: 405 Park Bench - Replace

Comments: Wood bench is permanently mounted in-ground. Posts are getting worn. Bench looks very old, but it is still functional. Replacement should be expected eventually.

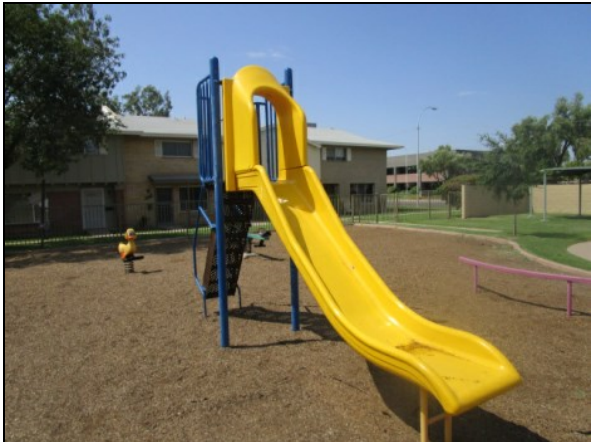
Comp #: 410 Playground Equipment - Replace

Comments: Equipment includes a climber, swing set, horizontal ladder, slide, spring rider, seesaw, and balance beam. This is identical set of equipment as the north recreation area. HOA should expect to completely replace the equipment at some point to renovate the playground.

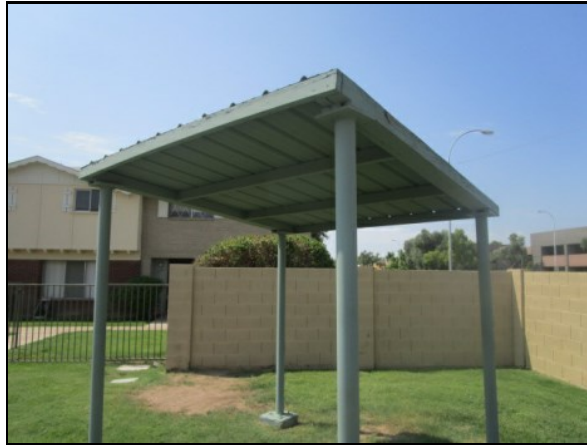
Comments: This ramada has a metal roof mounted on metal posts. Still in good condition. It does not appear to be that old. Periodic painting is included with the buildings. This component provides an allowance for major repairs or replacement.

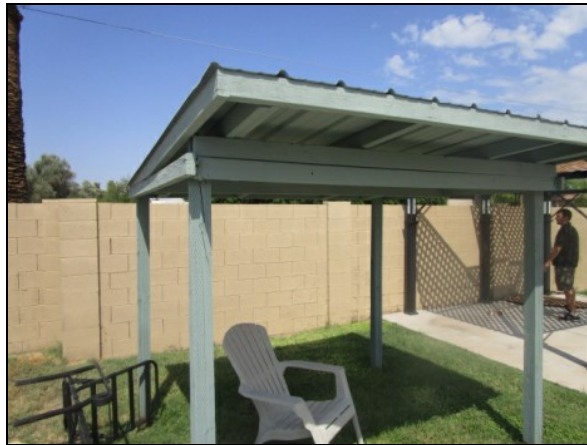
Comments: This ramada has a metal roof mounted on wood posts. Posts are old and rotted. Structure is loose and could be a hazard. This component provides an allowance for major repairs or replacement. Periodic painting is included with the buildings.

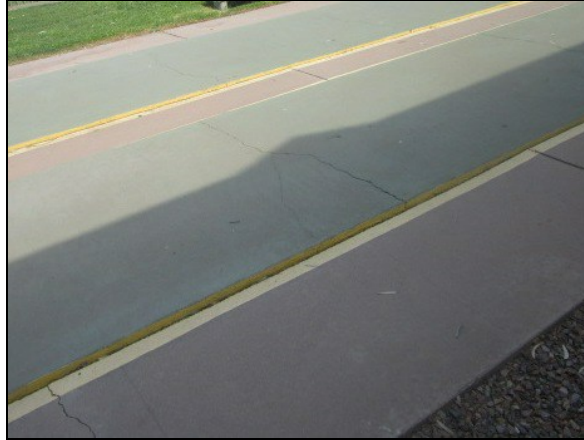
Comments: These are concrete shuffleboard courts. Coating is completely worn off. Surfaces are cracked and not useable for shuffleboard.

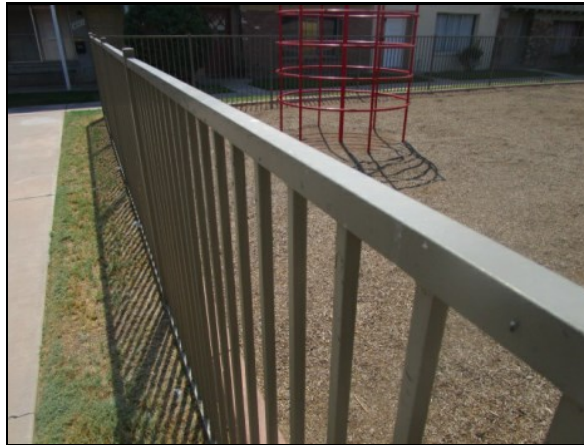
Comp #: 503 Metal Fence - Replace

Comments: Actual age of these fences is unknown, but they have been replaced in the past. Fences are mounted in the grass and exposed to sprinklers daily. This is expected to accelerate rusting and deterioration. Visible rusting noted, but posts are still securely mounted. Overall fair condition. Repaint regularly to inhibit the rusting and to protect the metal.

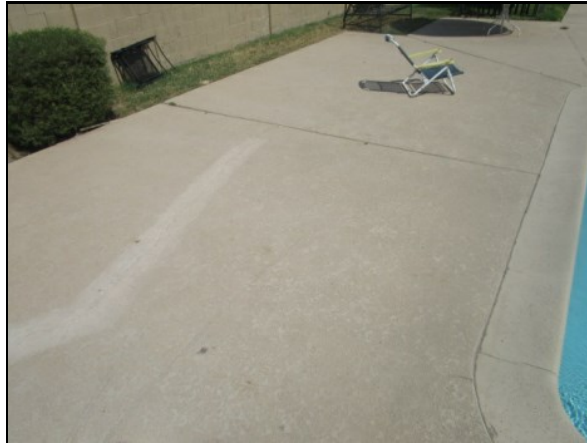
Comments: The pool deck has a combination of painted concrete and a kool deck coating. Surfaces are fair with some cracking. Plan to seal/coat in the near future, then plan for a larger resurfacing project.

Estimate to resurface deck coating & partially
replace concrete

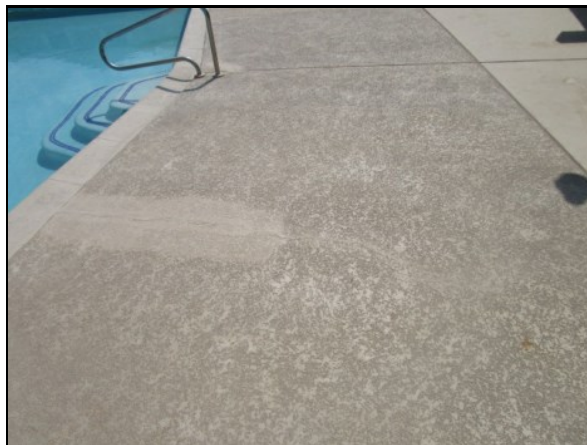
Comp #: 1201 Pool Deck - Seal/Repair

Comments: Pool deck is in fair-poor condition. It needs to be resealed at this point. This component funds to periodically patch cracks and seal/paint the deck to cover stains and restore the appearance.

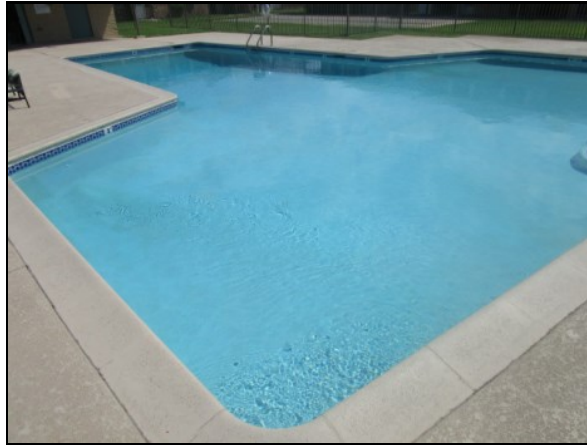
Comments: Pool has a white plaster surface with waterline tile. Some staining noted, but no signs of cracking or chipping. Actual age is unknown, but surface still appears to be in good shape.
